DAM SAFETY PROGRAM

September 2002

Montana Department of Natural Resources and Conservation

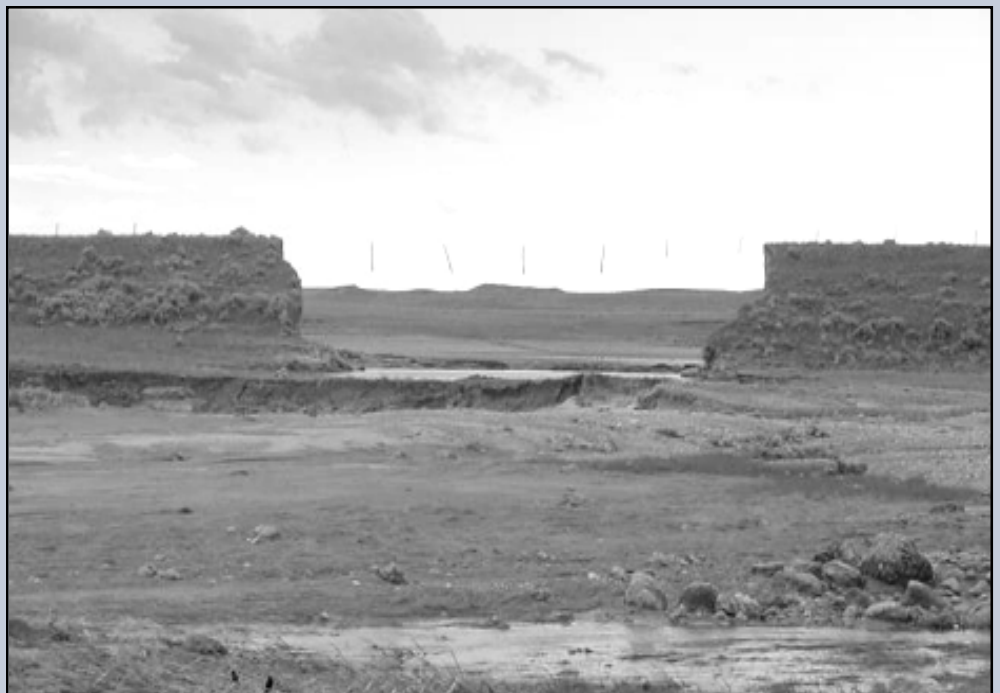
Taylor Creek Dam Failure - Photo by Candace Linder, NRCS

An irrigation dam in Garfield County failed on June 23, 2002. The dam was located on Taylor Creek approximately 22 miles southeast of Jordan, Montana. The estimated capacity of the dam when filled to the emergency spillway crest was 1,000 acre-feet. The height of the dam was approximately 32 feet.

Flash flood warnings had been issued the previous night, with a total of 3 to 5 inches of rainfall expected in Garfield County. At 6:00 a.m. on Sunday, June 23, the dam owner went to see how much water had accumulated in the large reservoir. When he arrived, water was running through the emergency spillway and leaking through a gopher hole on the embankment (near the top portion). The owner promptly called all of his downstream neighbors.

The water created a larger leak through this area and by 9:00 a.m. breached the embankment. There was no evidence of dam overtopping.
